Contract #: 04-0120F4Cty: SF/ALA Rte: 80 PM: 13.2/13.9File #: 1.28**WELDING INSPECTION REPORT****Resident Engineer:** Casey, William**Address:** 333 Burma Road**City:** Oakland, CA 94607**Report No:** WIR-027891**Date Inspected:** 30-Jun-2012**Project Name:** SAS Superstructure**OSM Arrival Time:** 700**Prime Contractor:** American Bridge/Fluor Enterprises, a JV**OSM Departure Time:** 1730**Contractor:** American Bridge/Fluor Enterprises, a JV**Location:** Job site**CWI Name:** N/A**CWI Present:** Yes No**Inspected CWI report:** Yes No N/A**Rod Oven in Use:** Yes No N/A**Electrode to specification:** Yes No N/A**Weld Procedures Followed:** Yes No N/A**Qualified Welders:** Yes No N/A**Verified Joint Fit-up:** Yes No N/A**Approved Drawings:** Yes No N/A**Approved WPS:** Yes No N/A**Delayed / Cancelled:** Yes No N/A**Bridge No:** 34-0006**Component:** Tower**Summary of Items Observed:**

Ultrasonic Testing (Tower ESW-E-045- "B" from Y=0~3800 Face B)

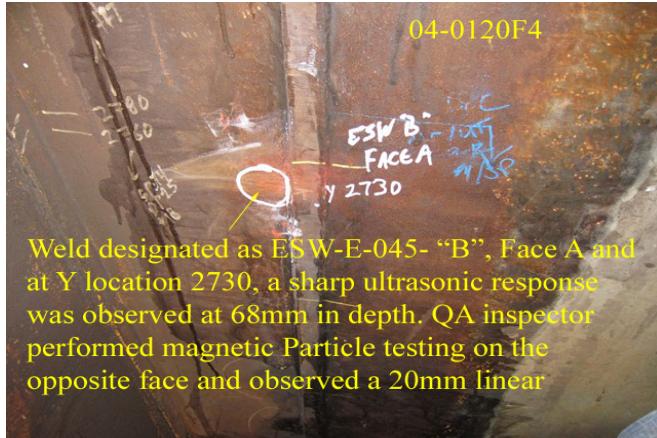
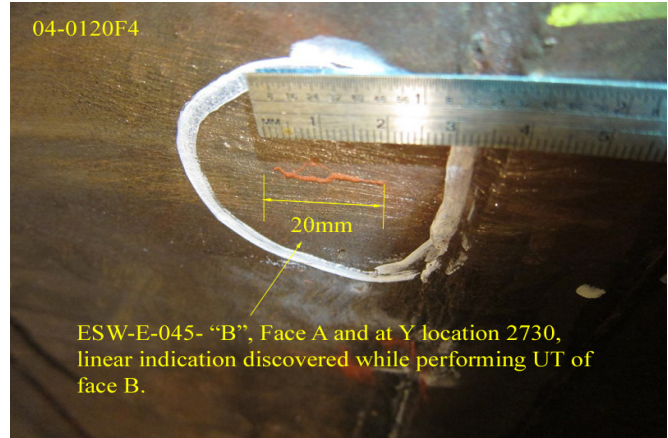
During the QA Ultrasonic inspection while scanning for transverse indications on the weld designated as ESW-E-045- "B", Face B and at Y location 2730, a sharp ultrasonic response was observed at 68mm in depth. Due to the sharp Ultrasonic response, the QA inspector performed magnetic Particle testing on the opposite face and observed a 20mm linear indication in the base metal adjacent to the weld as seen in the attached photograph.
